**Cold Regions Research  
and Engineering Laboratory**

**ERDC/CRREL TR-00-4**

## **Evaluation of Photovoltaic Panels at the South Pole Station**

# Evaluation of Photovoltaic Panels at the South Pole Station

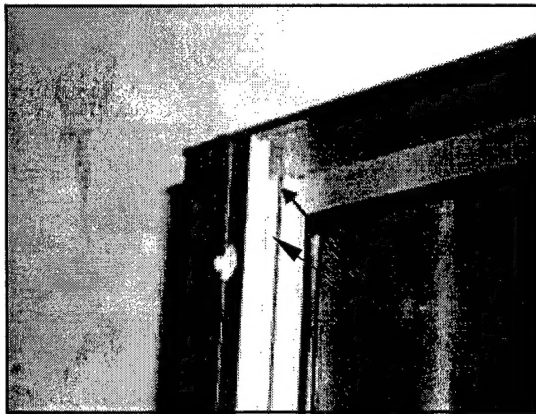
Figure 4. Details of PhotoComm, Inc., panel.

a. Top view of corner connections (pan head sheet metal screws).

b. Front view of corner connections.

c. Back view of corner connections (arrow points to sheet metal screw in open extruded channel).

On all four of the PhotoComm, Inc., panels that we inspected, the gasketed seal between the glazing and aluminum frame showed signs of failure. The gasketed seal was pulling out of the corners between the glazing surface and aluminum frame. Each panel showed some signs of aluminum frame weakness. The corner connections of the frame were loose and allowed considerable movement when a twisting motion was applied. Three of the frames showed signs of abuse; they had dents and or were bent. The glazing, panel back, and junction box were all free of defects.
